**U.S. Playing Card Company
Beech Street Facility**

PHASE I ENVIRONMENTAL SITE ASSESSMENT

United States Playing Card facility roofing review

PHOTO LOG: USPC Property Inspection—Norwood, Ohio
April 26, 2004

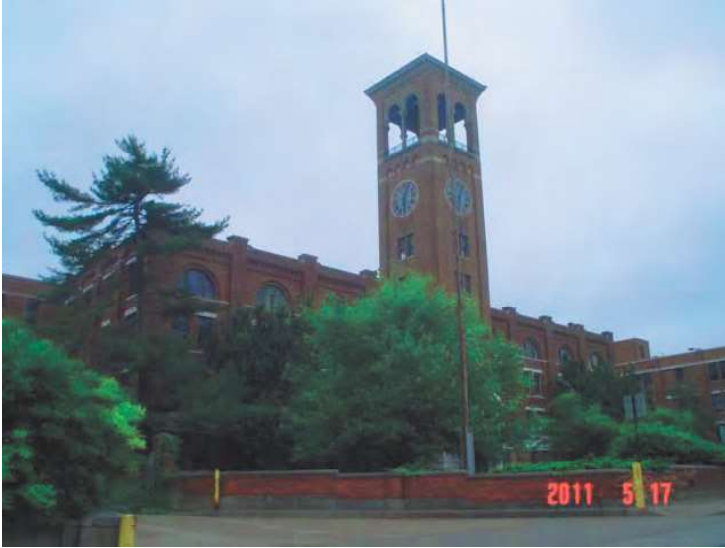
View of the Property facing east.

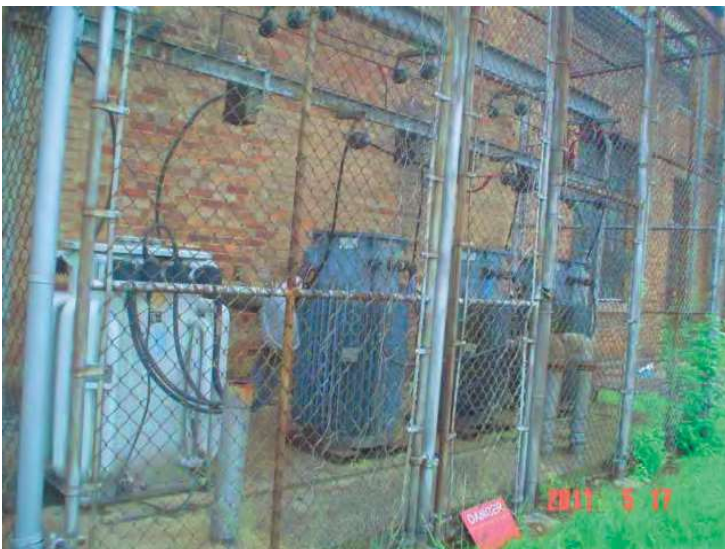
Transformers at Power House

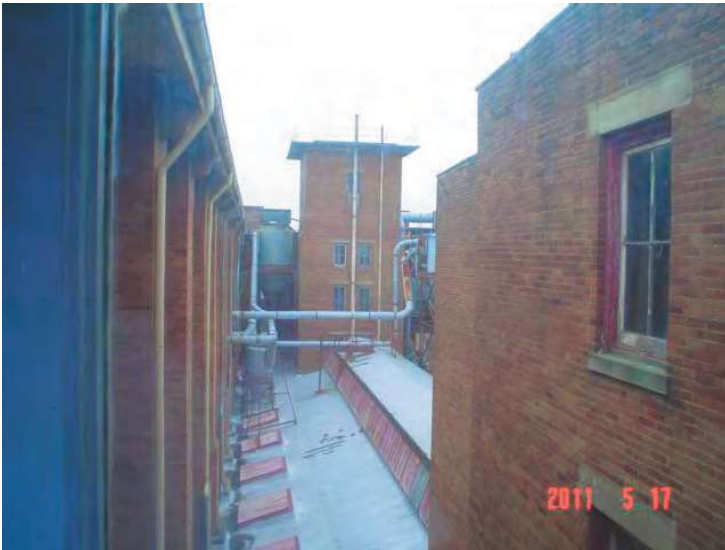
Baghouses

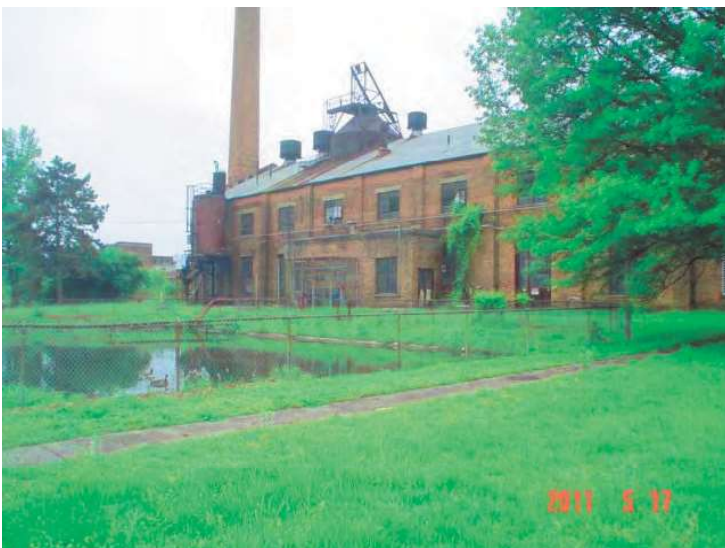
Power House and Fire Reservoir

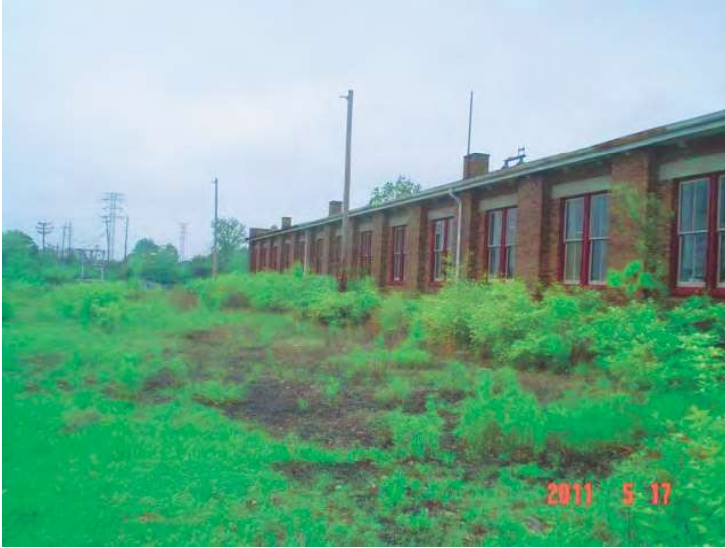
North side of Building 10

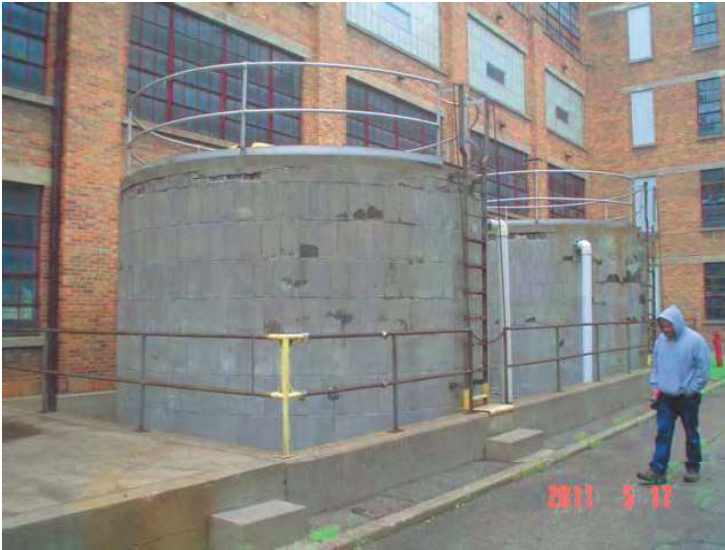
Mixing Tanks

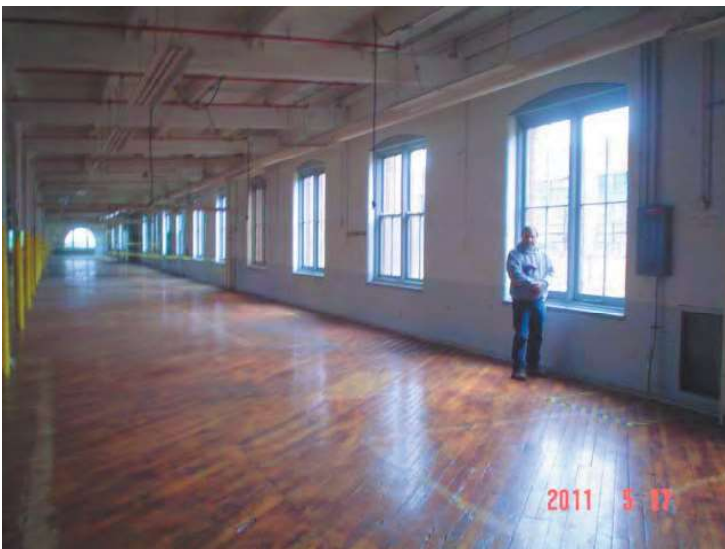
**Building Interior with Hard
Wood Floors**

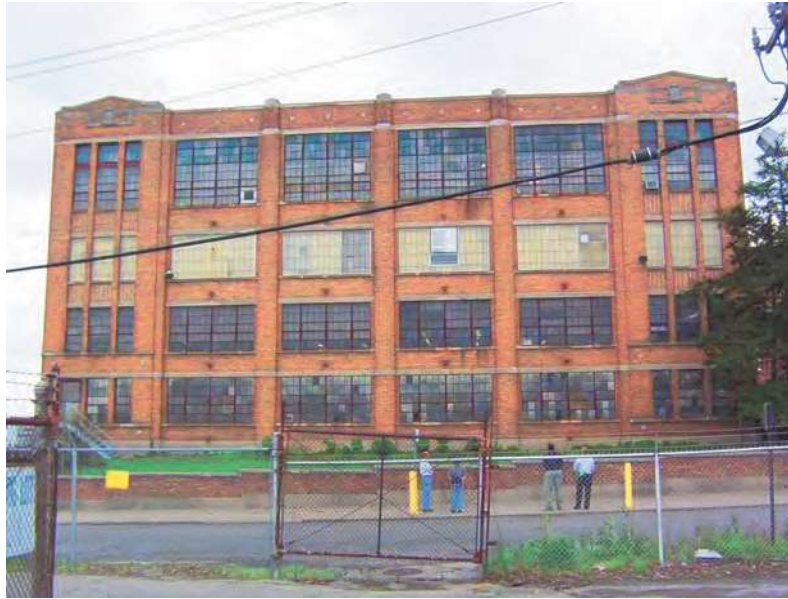
Building 01—Photo #1: West Elevation (Front)

The buildings exterior generally appears to be in good condition for a structure built in the early 1900's (photos 1- 12). The majority of the masonry appears to be in sound condition for a structure of it age. Areas requiring masonry tuck-pointing were observed; the estimated area for this work is approximately 200 SF.

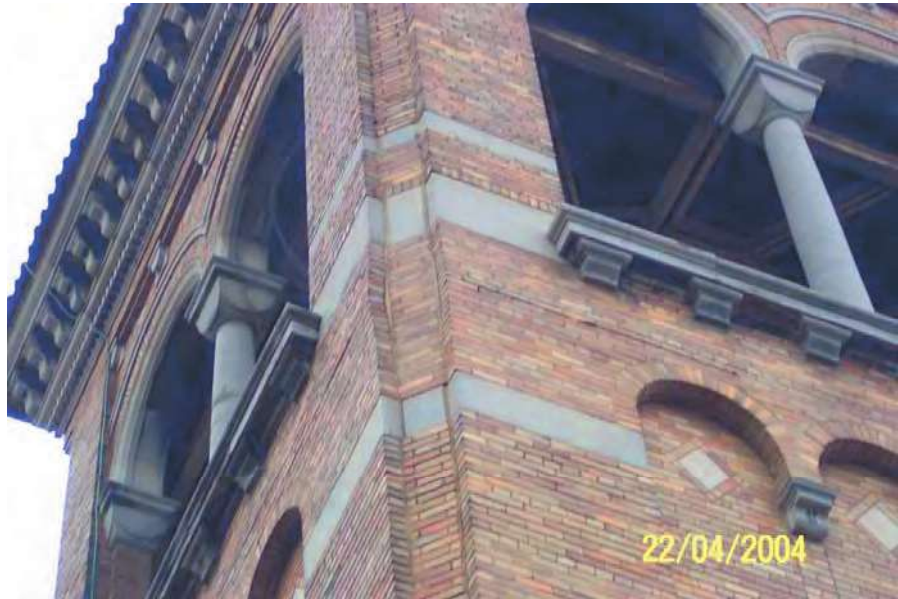
The buildings exterior generally appears to be in good condition for a structure built in the early 1900's (photos 13- 16). A four-story clock tower was added to the original building structure during the mid 1900's. The majority of the masonry appears to be in sound condition for a structure of its age. Observation revealed areas requiring masonry tuck pointing on the East and West building elevations. The estimated area for this work is approximately 300 SF. The clock tower masonry has areas where the masonry has bulged out of plan to its original location, this area shows past repairs that should be investigated and repaired by an experienced masonry restoration contractor. The other area of concern is the clock tower roof, evidence of broken roof tile was observed on the roof of building 02. The clock tower roof is located at the main entrance to the facility and is eight stories above the entrance. The proximity of the clock tower to the facility entrance does present possible liability issues of falling tile onto pedestrian accessing the facility; repair work for the clock tower roof should be a priority item.

Building 02—Photo #15: Clock Tower, Note Building Masonry

No major architectural issues within the building were noted during this observation review that would hinder continued use of this building. Window repair / replacement should be considered as building maintenance program. Remedial work on the clock tower masonry & roof tile should be considered a priority.

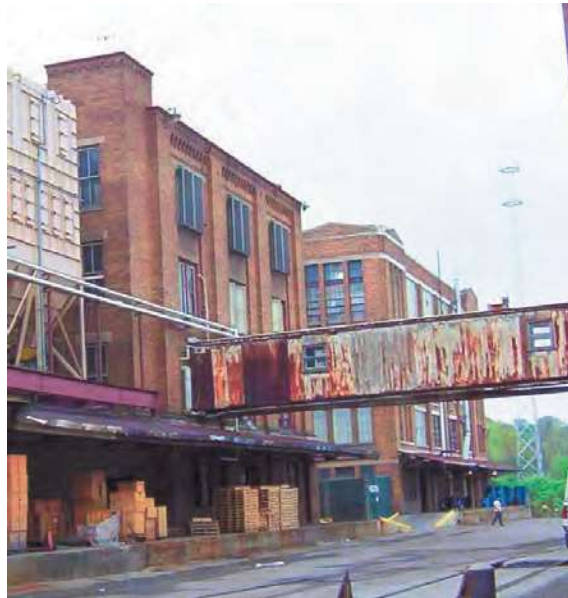
The buildings exterior generally appears to be in good condition for a structure built in the early to mid 1900's (photos 17- 21). The majority of the masonry appears to be in sound condition for a structure of it age. Observation revealed areas requiring masonry tuck pointing on the South and East building elevations above building 05 (with-in courtyard between Bldg. 1 & 3 and Bldg. 4 & 6). The estimated area for this work is approximately 450 SF +/- . The interior brick on both the south walls of the ground floor, below the window is in need of tuck-pointing. The majority of the mortar in this area has deteriorated into a granular state that easily falls from between the masonry. Remediation work is not critical but should be scheduled within the next five years to maintain the buildings function.

Building 03—Photo #17: East Elevation, Connector bridge to Building 09

No major architectural issues with in the building were noted during this observation review that would hinder continued use of this building. Window replacement should be considered as building maintenance program. Tuck pointing the masonry joints on the exterior & interior walls should be planned for in building maintenance program.

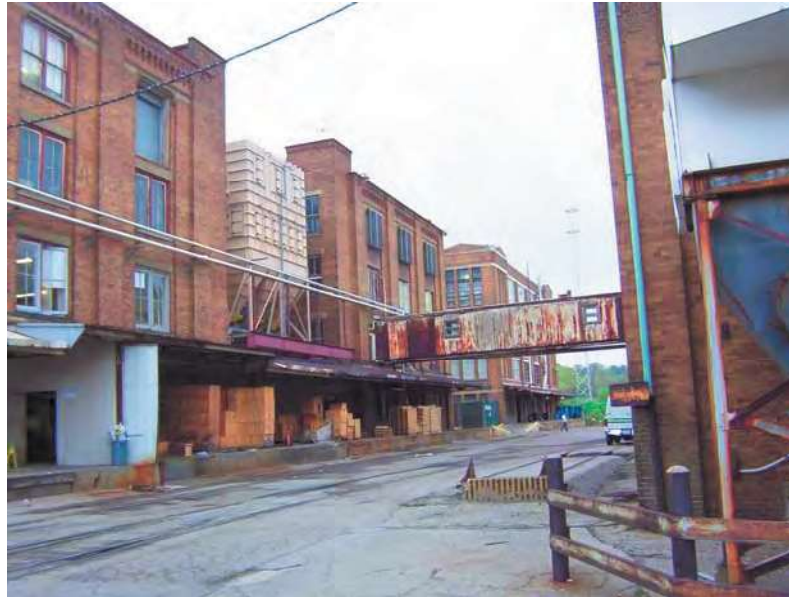
The buildings exterior generally appears to be in good condition for a structure built in the early to mid 1900's (photos 22- 33). The majority of the masonry appears to be in sound condition for a structure of it age. Observation revealed areas requiring masonry tuck pointing on the North, East and South building elevations (with-in courtyard between Bldg. 4 & 6). The estimated area for this work is approximately 550 SF +/- . The interior brick on both the south walls of the ground floor, below the window is in need of tuck-pointing. The majority of the mortar in this area has deteriorated into a granular state that easily falls from between the masonry. Remediation work is not critical but should be scheduled within the next five years to maintain the buildings function. The pre-cast concrete window lintels and sills on the North & East and South building elevation are generally in sound condition, some of the lintels have exposed reinforcing steel and sprawled concrete, these will require repair work to prevent continued deterioration.

Buildings 04 (Foreground), Building 05 (Dust Collectors), and Building 03 (Background) - Photo #22.

No major architectural issues with in the building were noted during this observation review that would hinder continued use of this building. Window replacement should be considered as building maintenance program. Tuck pointing the masonry joints on the exterior & interior walls should be planned for in building maintenance program.

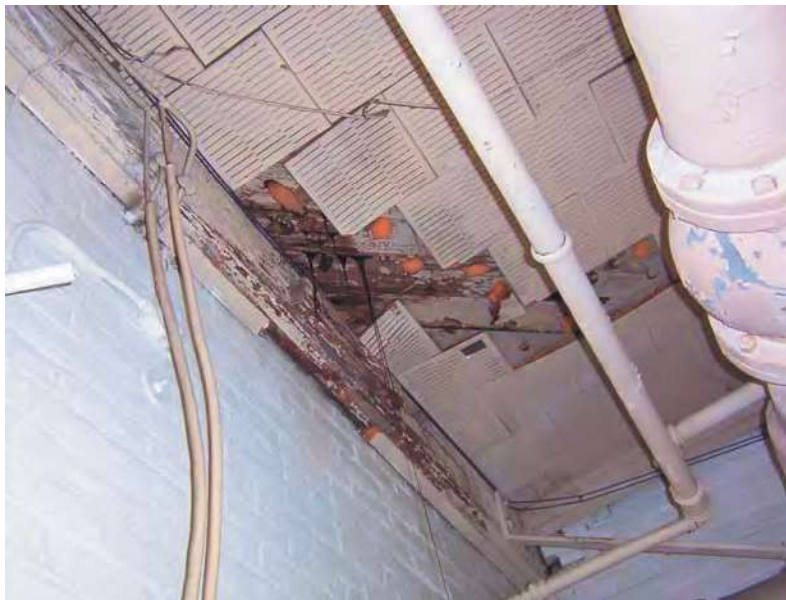
Building 04—Photo #25: Fourth floor roof deck, roofing tar dripping through deck boards.

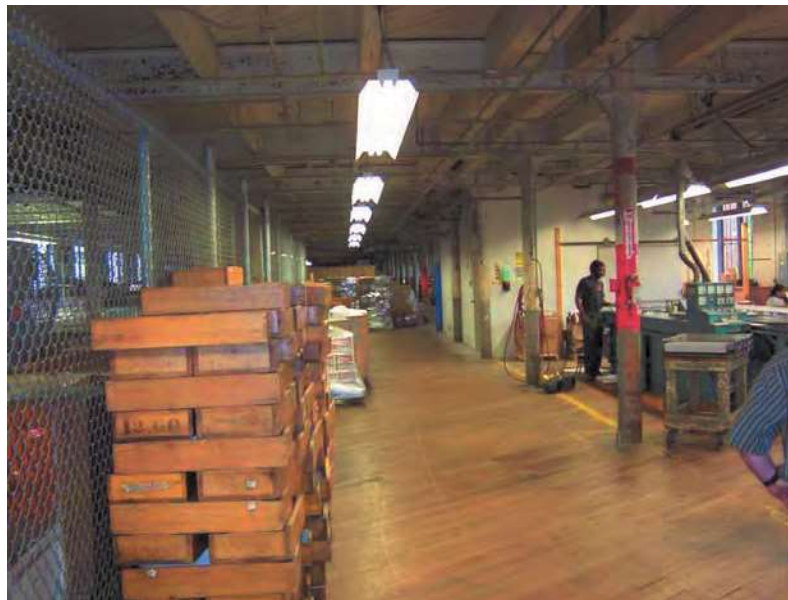
Building 04—Photo #27: Third floor, wood flooring.

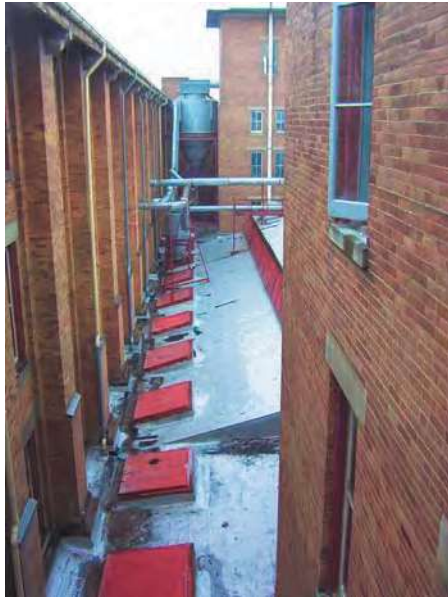
Building 05—Photo #34: Roof

The most significant problem with this building is the condition of the roof: see roofing review for additional comments and recommendations. No architectural issues with in the building were noted during this observation review that would hinder continued use of this building. Tuck pointing the masonry joints on the exterior & interior walls should be planned for in building maintenance program.

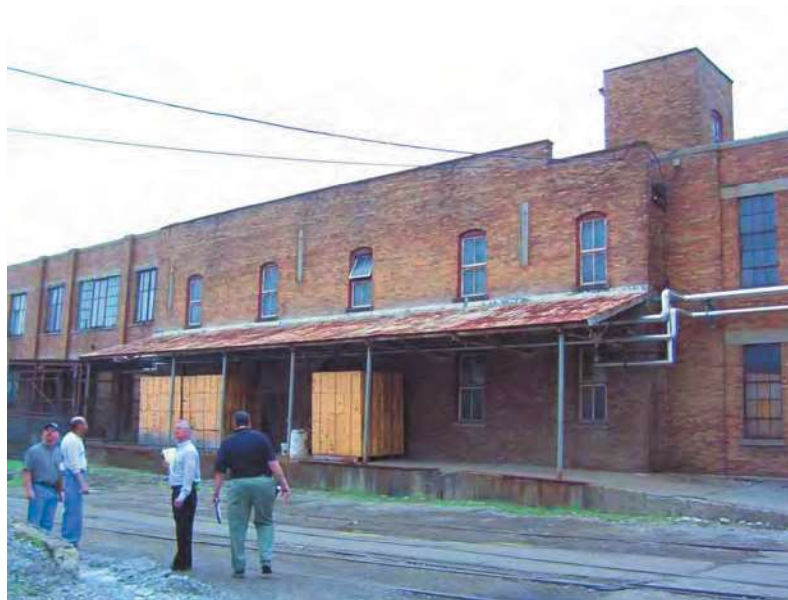
The metal awning located on the East elevation shows signs of age, some corrugated roof panels should be replaced, however the structural frame overall appears to be in satisfactory shape.

Building 06—Photo #41: East Elevation. Note metal awning at second floor steel channel thrust blocks. Holding masonry in place.

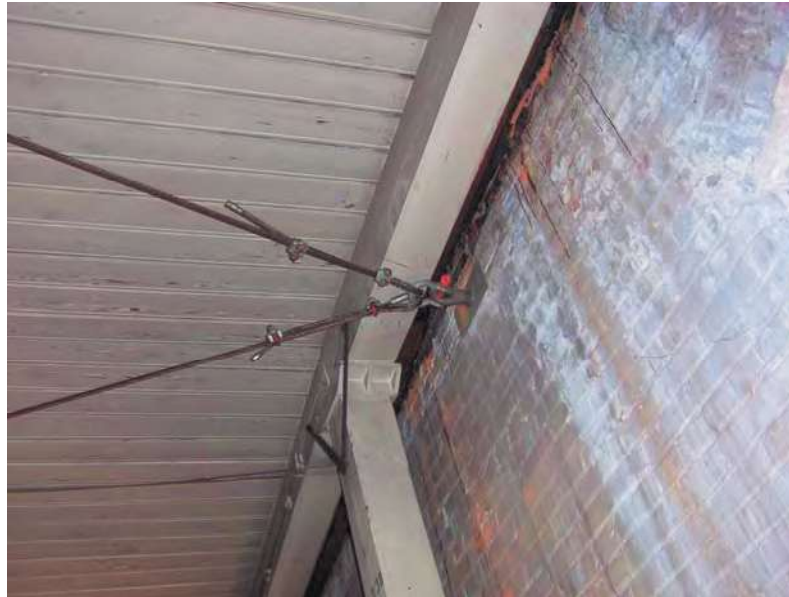
Building 06—Photo #42: Second floor. Cables through bolted steel channel thrust block on exterior wall. See previous photo. Cables are tied back to interior brick wall thrust block, see photo below.

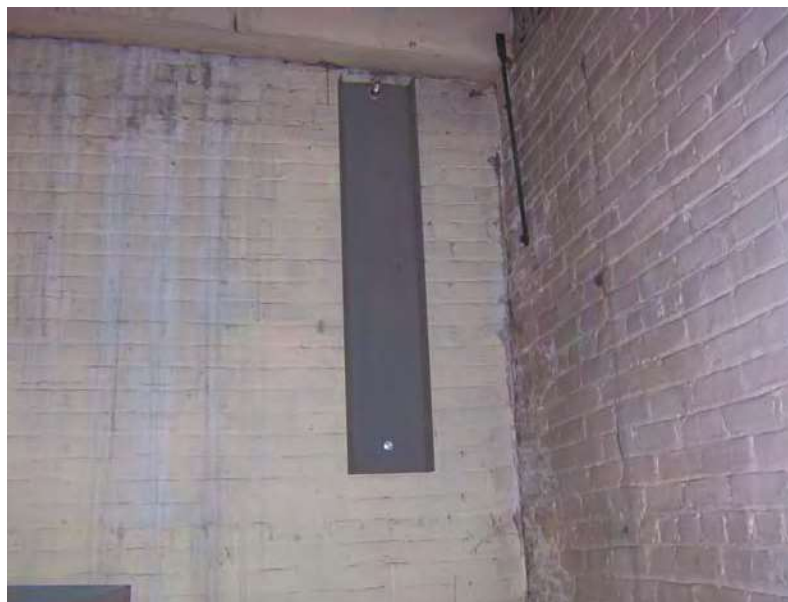
Building 06—Photo #43: Second floor, interior wall thrust block.

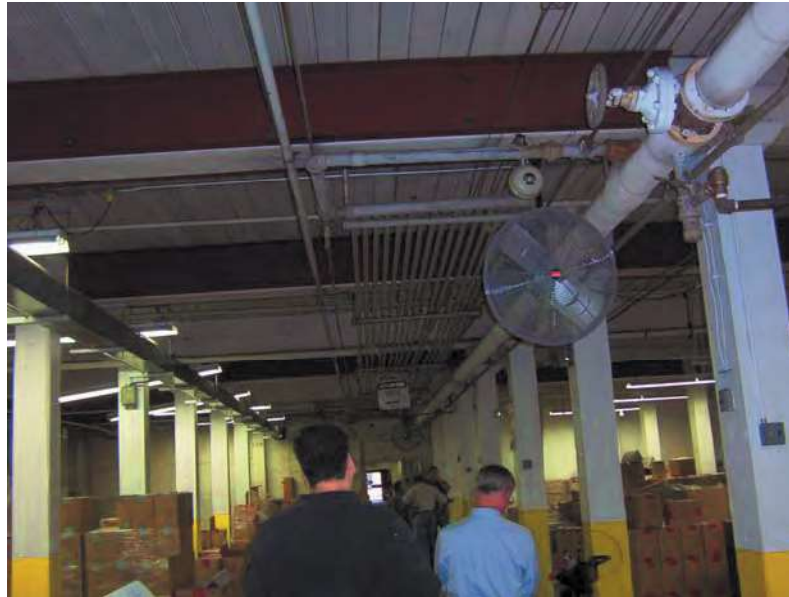
The buildings exterior generally appears to be in good condition for a structure built in the early to mid 1900's (photos 40- 49). The majority of the masonry appears to be in sound condition. Observation revealed areas requiring masonry tuck pointing on the North, East and South building elevations (with-in courtyard between Bldg. 4 & 6 and bldg. 6 & 7). The estimated area for this work is approximately 500 SF +/- . Observation noted that masonry of east wall at the second floor has bowed out and away from the buildings structural frame; measures were taken in the past to stabilize the masonry wall with the use of cables and shear blocks that tie back to an interior masonry wall, Photos (42-43). Many of the beams supporting the second floor have been reinforced with steel channels bolted to each side of the beam: presumably to stiffen the beam allowing it to carry the load for product storage, Photo 44.

Building 06—Photo #44: First floor. Existing wood beam reinforced with steel channel on each side.

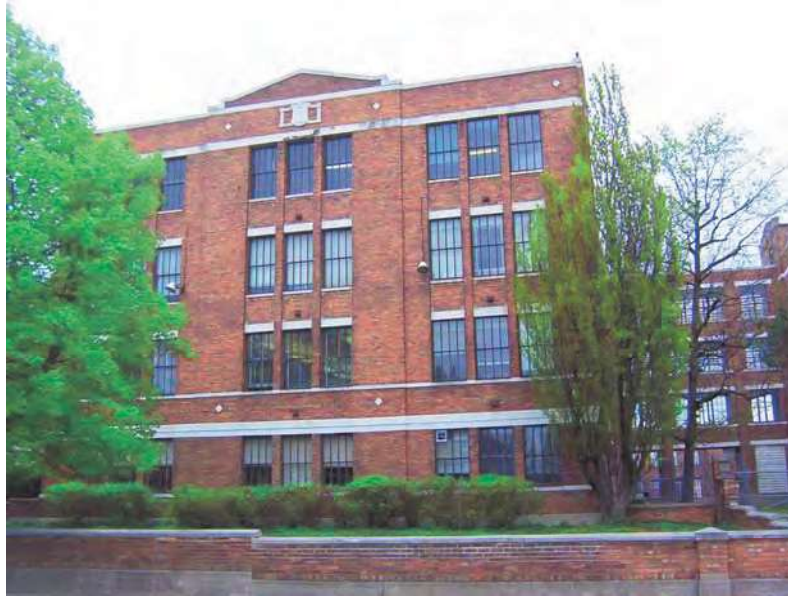
Building 06A—Photo #46: Southwest corner

The buildings exterior generally appears to be in good condition for a structure built in the early to mid 1900's (photos 45- 47). The majority of the masonry appears to be in sound condition for a structure of its age. Observation revealed areas requiring masonry tuck pointing on the East and South building elevations. The estimated area for this work is approximately 450 SF +/- . The pre-cast concrete window lintels and sills on the East and South building elevation are generally in sound condition, some of the lintels have exposed reinforcing steel and spalled concrete, these will require repair work to prevent continued deterioration.

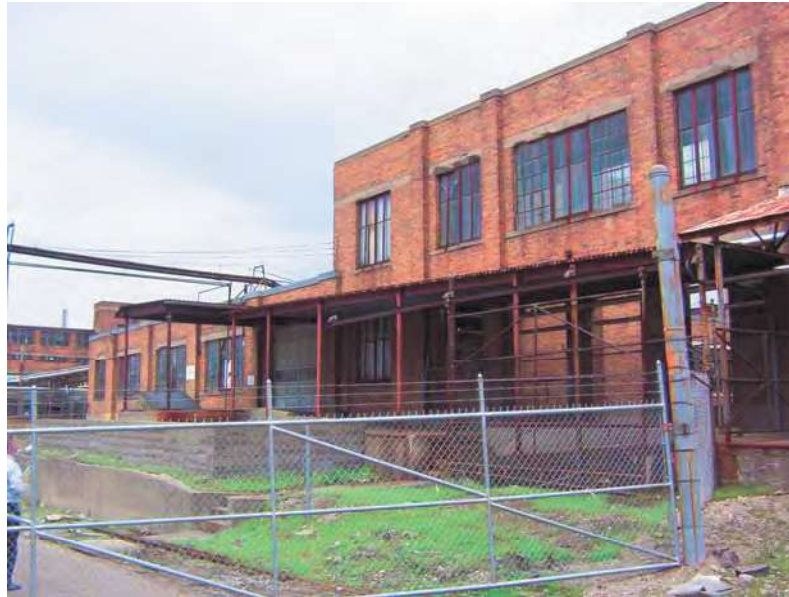
Photo #48: Connector between Building 06 (Right) and Building 07 (Left) - East Elevation. Concrete beam supporting second floor has spawled concrete exposing reinforcing steel. See photo below.

The pre-cast concrete lintels/beam supporting the second floor of the connector building between buildings 04 & 06 has spawled concrete that has exposing the reinforcing steel. This condition should be fixed to prevent further deterioration of the concrete beam. Photo 48 and 49.

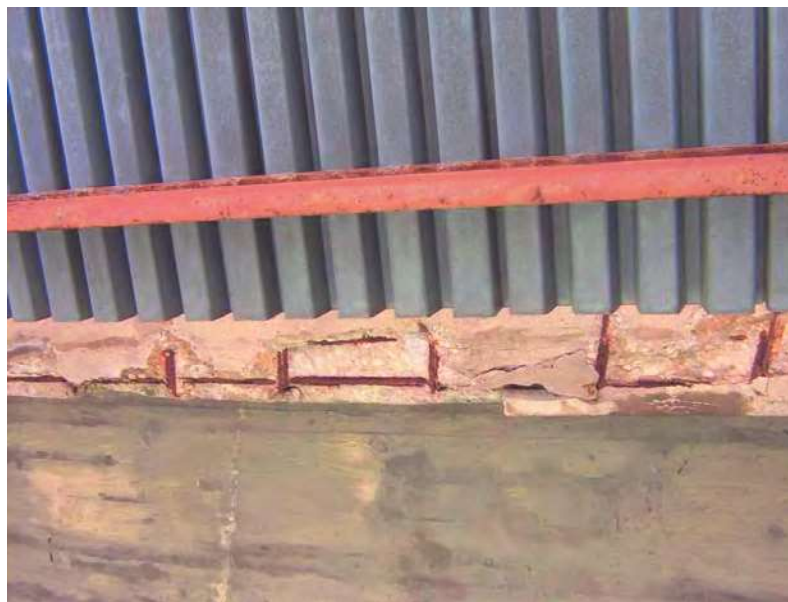
Photo #49: Concrete beam supporting connector floor above.

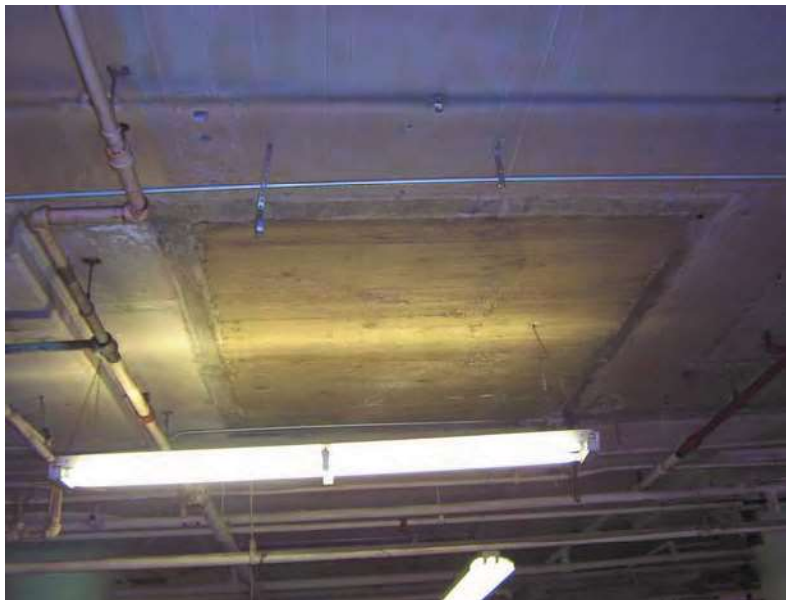
Building 07—Photo #61: Infill slab at abandoned elevator shaft.

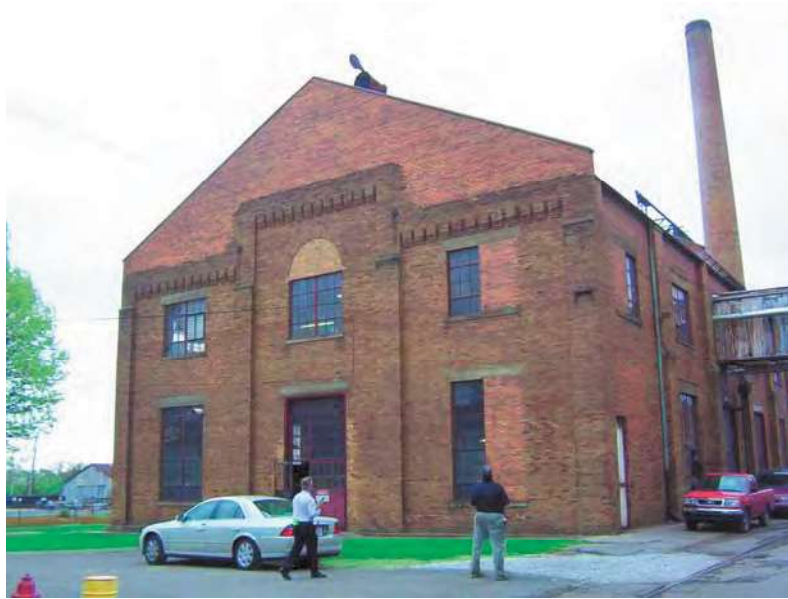
The buildings exterior generally appears to be in sound condition for a structure built in the early to mid 1900's (photos 62- 67). The original flat roof structure and masonry parapet were removed during a 1940+/- renovation of the boiler plant area of this building. The flat roof was replaced with gable shaped (sloped roof) steel trusses system. The masonry used during this renovation is a slightly different color that the original masonry and is visible in attached photographs.

Building 09—Photo #62: North Elevation. Note later addition of gable roof trusses and masonry end gable.

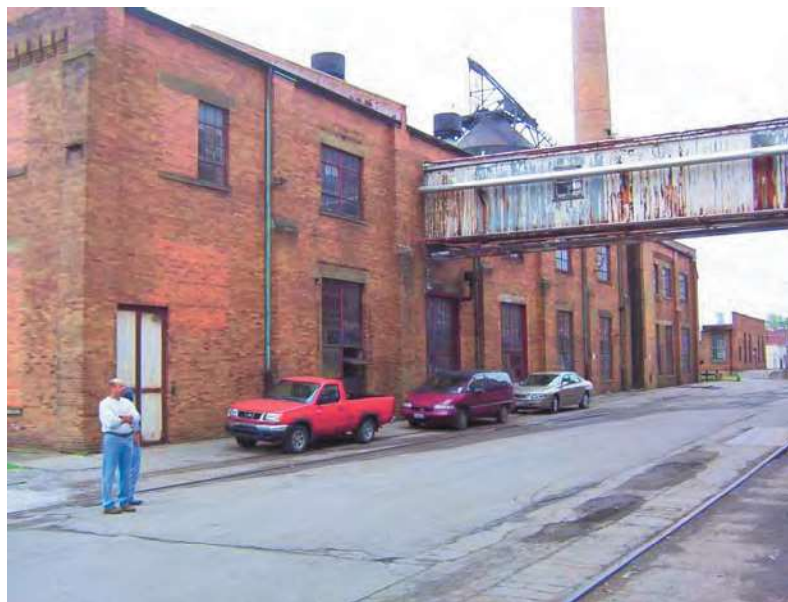
Building 09—Photo #63: West Elevation. Connector bridge extending over drive to Building 03.

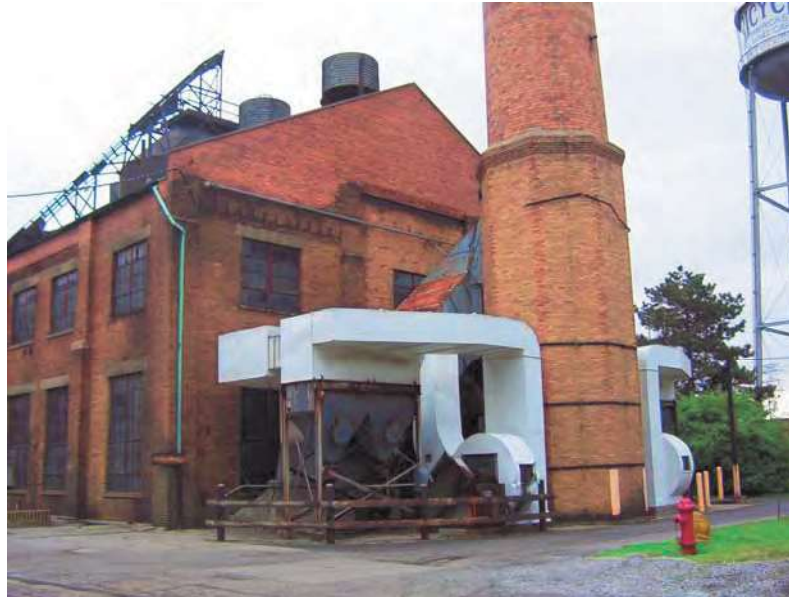
Building 09—Photo #64: South Elevation. Note framework on roof for abandoned coal lift.

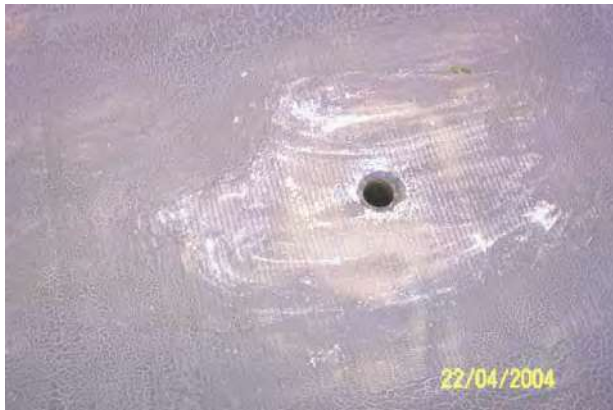
Building 01—Roof Photo #1: Hole from abandoned roof top equipment. Patch and repair.

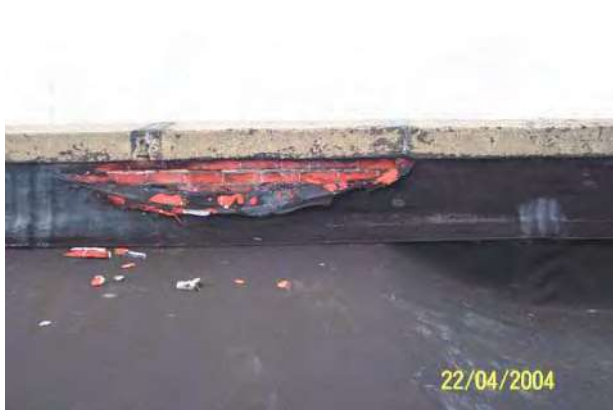
Building 01—Roof Photo #6: Observed deteriorating membrane flashing over brick parapet. Recommend repair brick and replace membrane flashing.

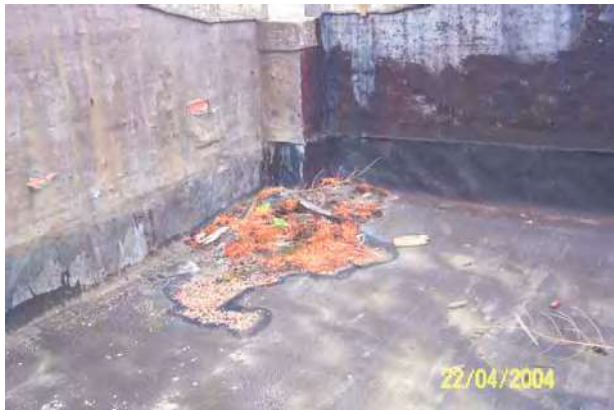
Building 01—Roof Photo #8: Observed deteriorated parapet flashing. Repair or replace required.

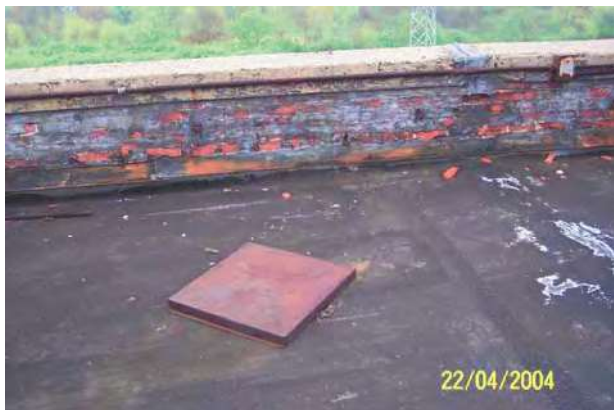
Building 01—Roof Photo #12: Abandoned equipment mounting under cover.

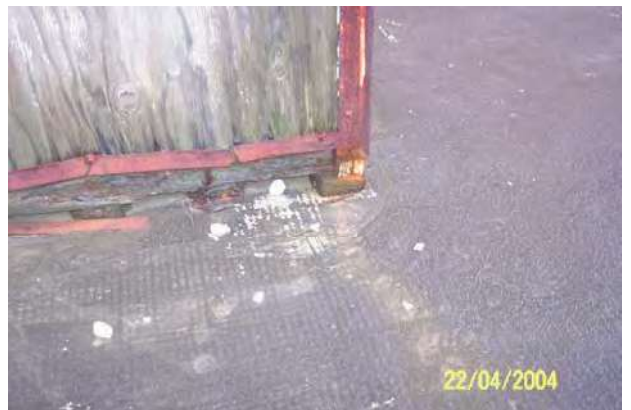
Building 01—Roof Photo #13: Rotting wood structure. No flashing around base. See Photo #14. Structure could be removed.

Building 01—Roof Photo #14: Abandoned wood structure. Recommend removal, patch/ repair roofing.

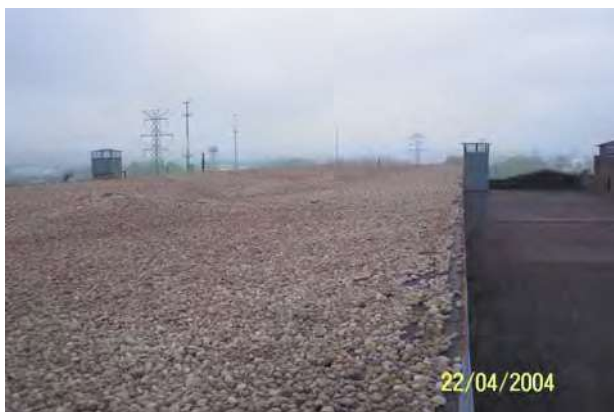
Building 01—Roof Photo #18: Clerestory roof. Gravel ballast over single ply membrane roofing.

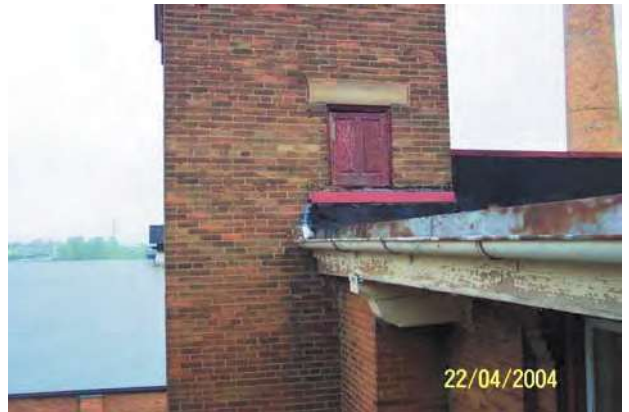
Building 04—Roof Photo #27: Gutter and gutter board. Required maintenance patching and painting. Note masonry beyond requires tuck pointing.

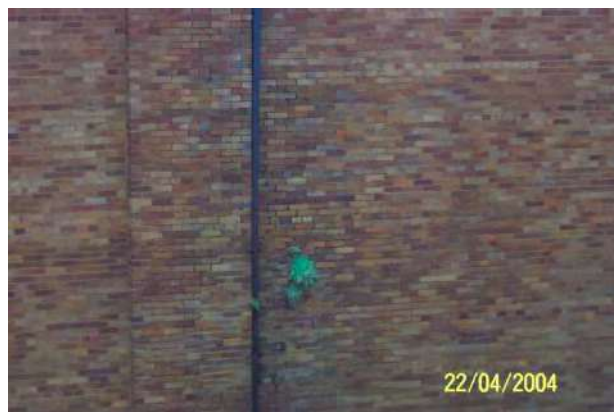
Building 06—Roof Photo #33: Water damaged masonry around downspout. Extensive tuck pointing required. Removal of plant within joints required.

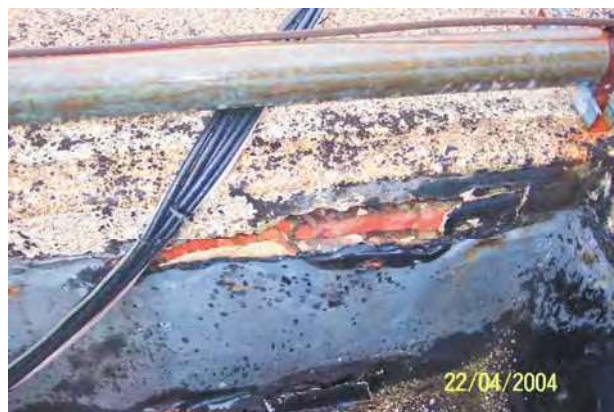
Connector between Building 04 and 06—Roof Photo #37: Observed damaged flashing on parapet. Repair required.

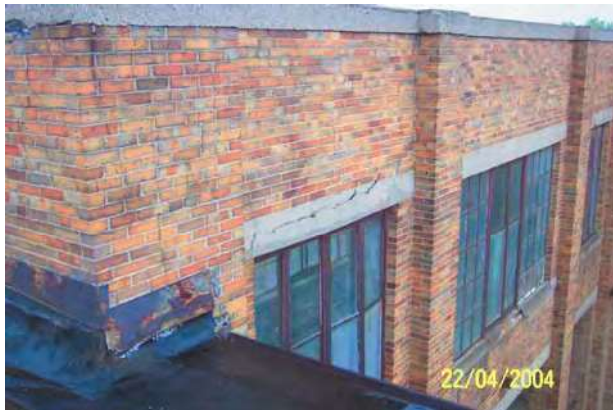
Building 06—Roof Photo #38: Observed evidence of masonry movement and deterioration of concrete lintel of windows.

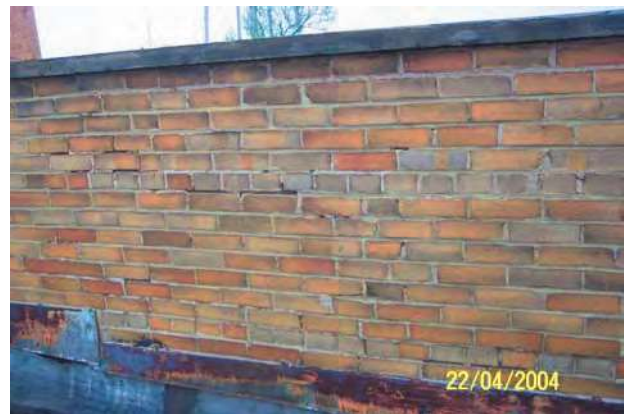
Building 06—Roof Photo #41: Tuck point masonry is required.

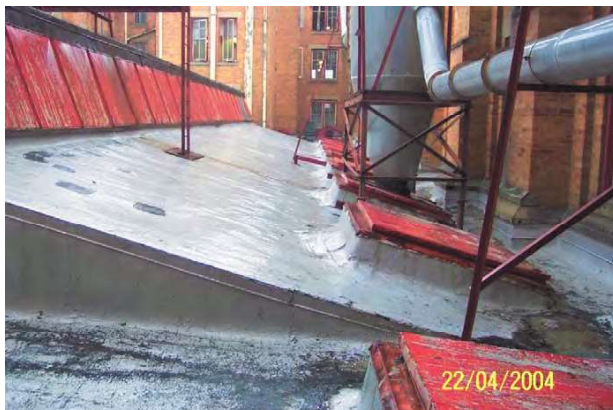
Building 05—Roof Photo #43: Observed multiple past roof repairs. Observation of underside of roof deck indicates past roofing leaks.

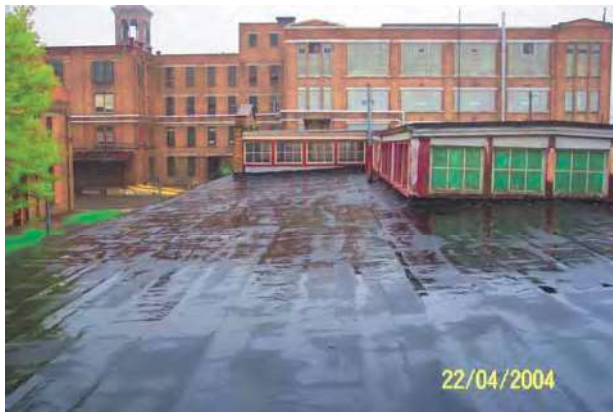
Building 10—Roof Photo #48: Observed ongoing roof leaks from inside of Building 10. Most notably around base of clerestory structure.
